# Apartment Inspection Report

## 3 Sempołowskiej Street Apartment

| AREA | INSPECTION DATE | REPORT DATE |
|---|---|---|
| 27.25 m <sup>2</sup> | 11 September 2026 | 12 September 2026 |

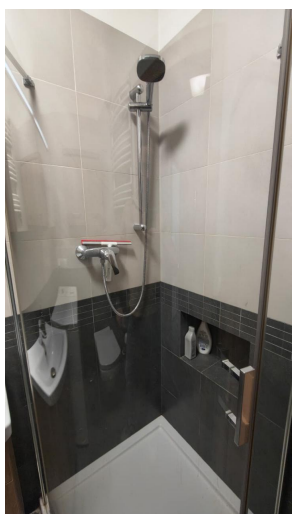
| Item | Condition and comments |
|---|---|
| Shower enclosure | Corner unit, 80 x 80 cm; good condition; renewal of the sealant is recommended |

**B03** 80 x 80 cm shower enclosure with shower mixer.

| Priority | Scope of work |
|---|---|
| P2 | Renew the sealant joints around the shower enclosure |
| P3 | Replace the shower mixer or set with a rain shower model compatible with the existing connections |

| No | Priority | Work | Acceptance criterion |
|---|---|---|---|
| 1 | P2 | Renew the sealant joints in the shower enclosure | Continuous, neat seal with no leakage during testing |
| 7 | P3 | Replace the shower mixer or set with a rain shower model | Compatible connections, stable temperature and no leaks |

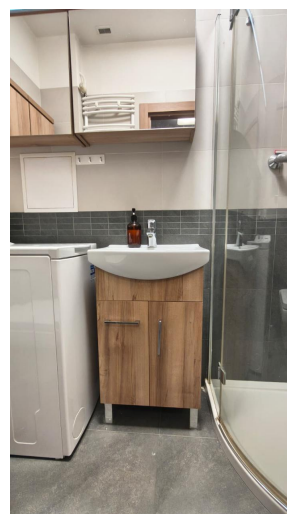
| Item | Condition and comments |
|---|---|
| Washbasin and cabinet | Good condition; cabinet handle requires repair |

**B04** Washbasin with cabinet and top-loading washing machine.

| Priority | Scope of work |
|---|---|
| P2 | Repair the cabinet handle |

| No | Priority | Work | Acceptance criterion |
|---|---|---|---|
| 3 | P2 | Repair the bathroom cabinet handle | Handle secure and cabinet front opens correctly |

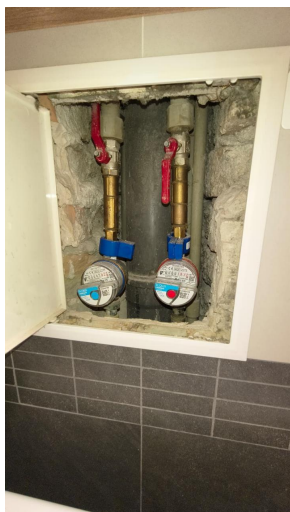
**B07** Water connections, valves and meters in the access opening.

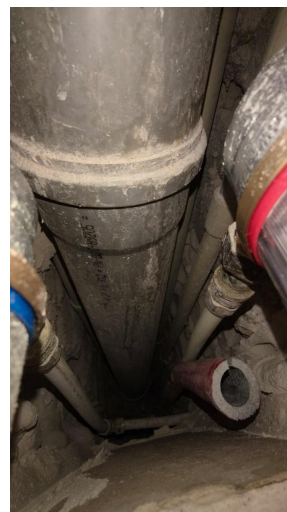
| System | Condition or scope | Verification |
|---|---|---|
| Building risers | Main water and drainage risers replaced | Checked during the inspection; the riser is documented in photograph B08 |

**B08** Installation risers visible through the access opening.

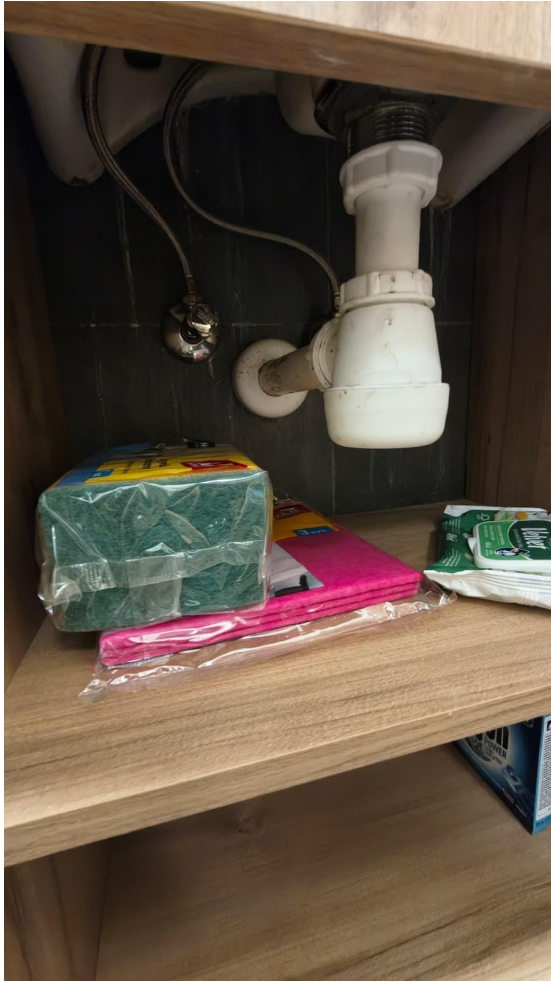
**B09** Water and drainage connections beneath the washbasin.

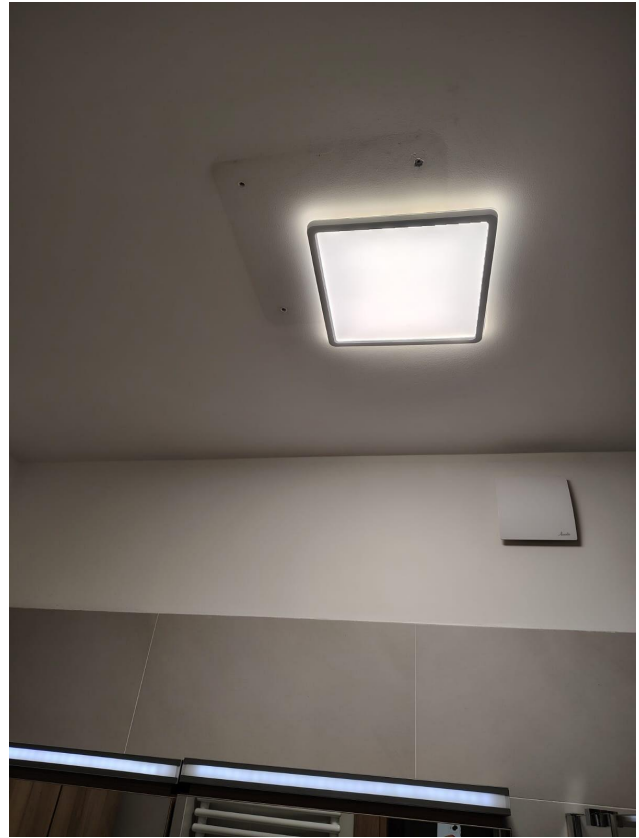
**B10** Ceiling after replacement of the light fitting, with visible fixing holes.

| Priority | Scope of work |
|---|---|
| P2 | Fill the holes left by the previous light fitting and repaint the ceiling |

| No | Priority | Work | Acceptance criterion |
|---|---|---|---|
| 2 | P2 | Fill the holes left by the previous light fitting and repaint the bathroom ceiling | Uniform finish with no visible holes or surface defects |

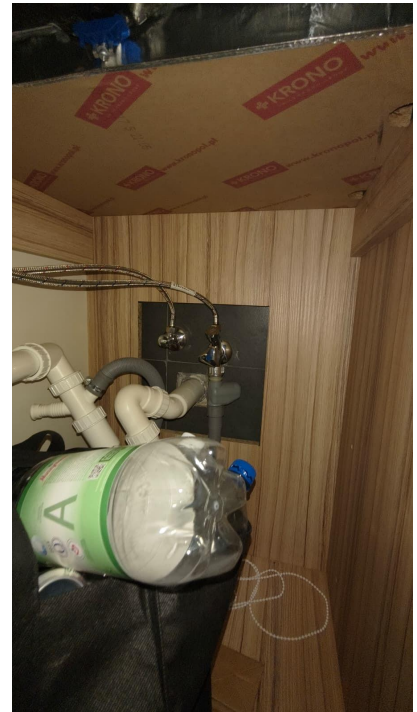
**K15** Replaced water and drainage connections beneath the kitchen sink.

The connections beneath the sink are accessible inside the cabinet. Before handover, test the sink and dishwasher and confirm that the connections remain dry.

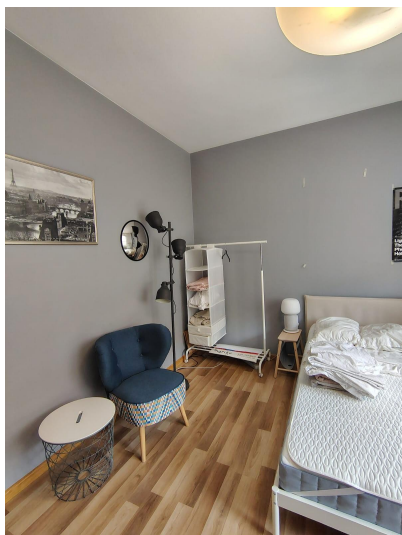
**BR01** Bedroom with bed, armchair and open clothes rail.

| Priority | Scope of work |
|---|---|
| P3 | Purchase an enclosed wardrobe to replace the open clothes rail |

| No | Priority | Work | Acceptance criterion |
|---|---|---|---|
| 8 | P3 | Replace the open clothes rail in the bedroom with an enclosed wardrobe | Wardrobe is stable, practical and safely positioned |

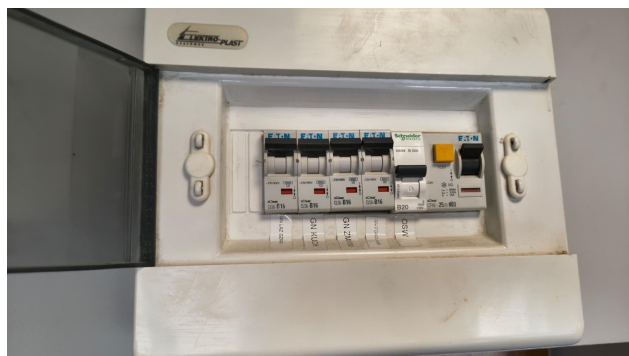
| Item | Condition and comments |
|---|---|
| Electrical distribution board | New; shown in photograph H03 |

**H03** New electrical distribution board.

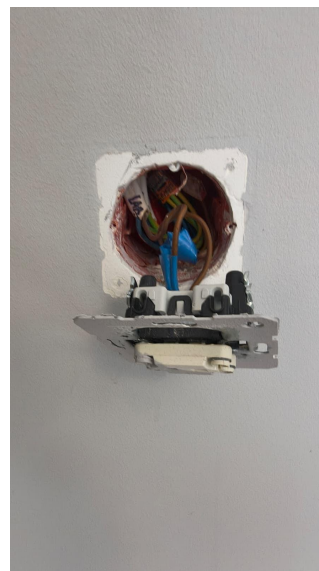
**Installations** The internal electrical installation has been replaced and a new distribution board installed in the hallway. In photograph H04, the switch was temporarily removed to document the replaced wiring; it was reinstalled after the photograph was taken.

| Status | Description |
|---|---|
| Information | The switch shown in photograph H04 has been reinstalled; the photograph does not show a defect |

**H04** Switch temporarily removed to show the replaced wiring; the switch has been reinstalled.
